## **BBN Technical Memorandum No. 1270**

### **ANIMIDA Phase I: Ambient and Industrial Noise Measurements Near the Northstar and Liberty Sites During April 2000**

**Arctic Nearshore Impact Monitoring in the Development Area  
(ANIMIDA)**

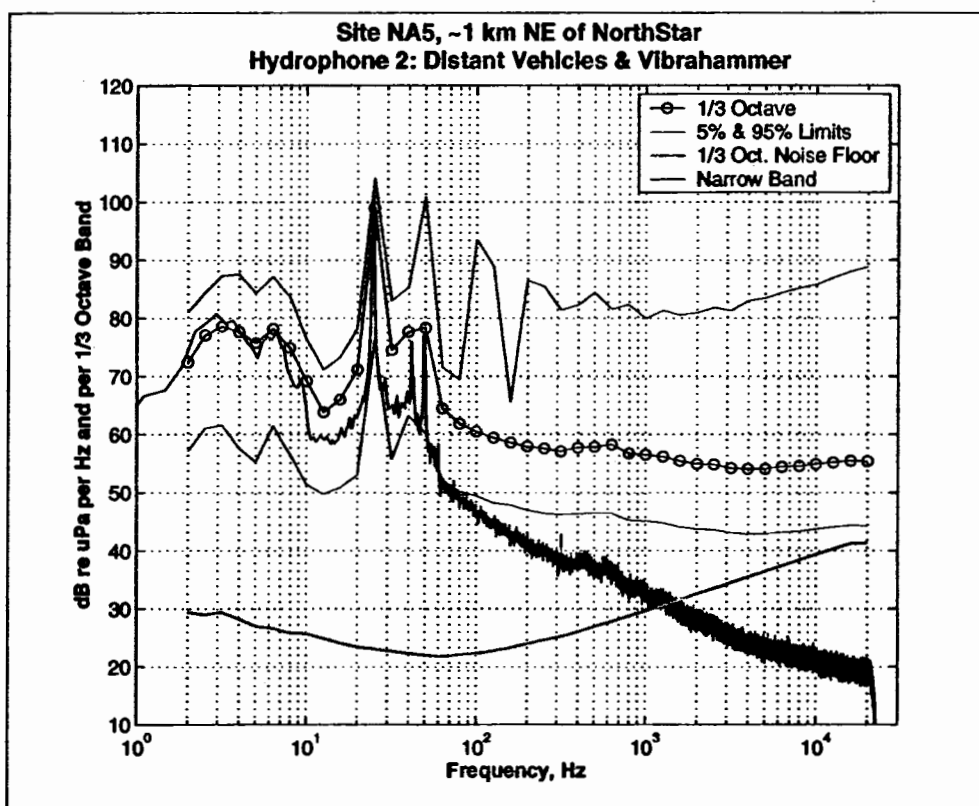
Figure 3.1.4- 6. Mid channel underwater noise levels at site NA5; vibrahammer. (8-1200)

Underwater noise from the two sensors during moderate vibrahammer excitation are shown in Figures 3.1.4-5 and 3.1.4-6 for the deep and mid channel hydrophones, respectively. The dominant features are the tonal near 23 Hz, the high energy below 10 Hz, and a few tonals above the strong 23 Hz peak. As before, the near bottom sensor has slightly more noise than the mid-channel sensor. Under moderate vibrahammer noise, the 1/3 OB containing the 23 Hz tonal was seen to vary in level from 96 to 106 dB re  $\mu\text{Pa}$  on H1 and 92 to 102 dB re  $\mu\text{Pa}$  on H2. Over the rest of the spectral band, the noise spectra levels remained quite consistent ( $\pm 2$  dB).

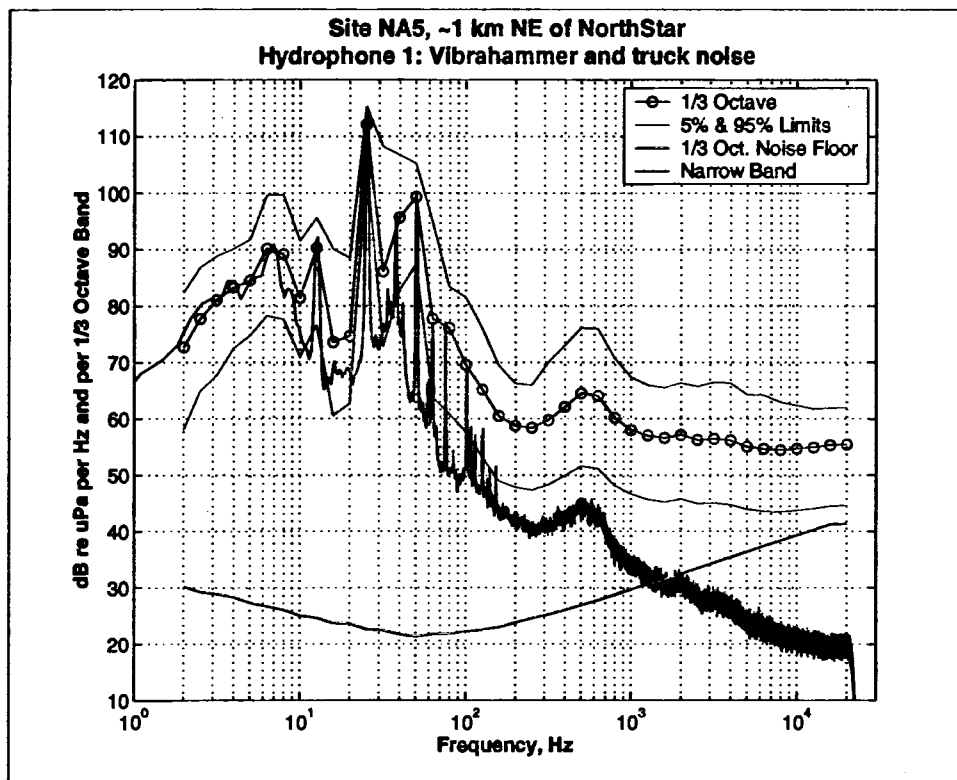
Figure 3.1.4- 7. Near bottom underwater noise levels at site NA5; strong vibrahammer. (10-0000)

the broad low frequency noise hump below 20 Hz. In-air noise levels at this time were shown in Figure 3.1.4-9 while the underwater noise levels were presented in Figures 3.1.4-7 and 3.1.4-8. All four plots show a strong 23 Hz tonal.

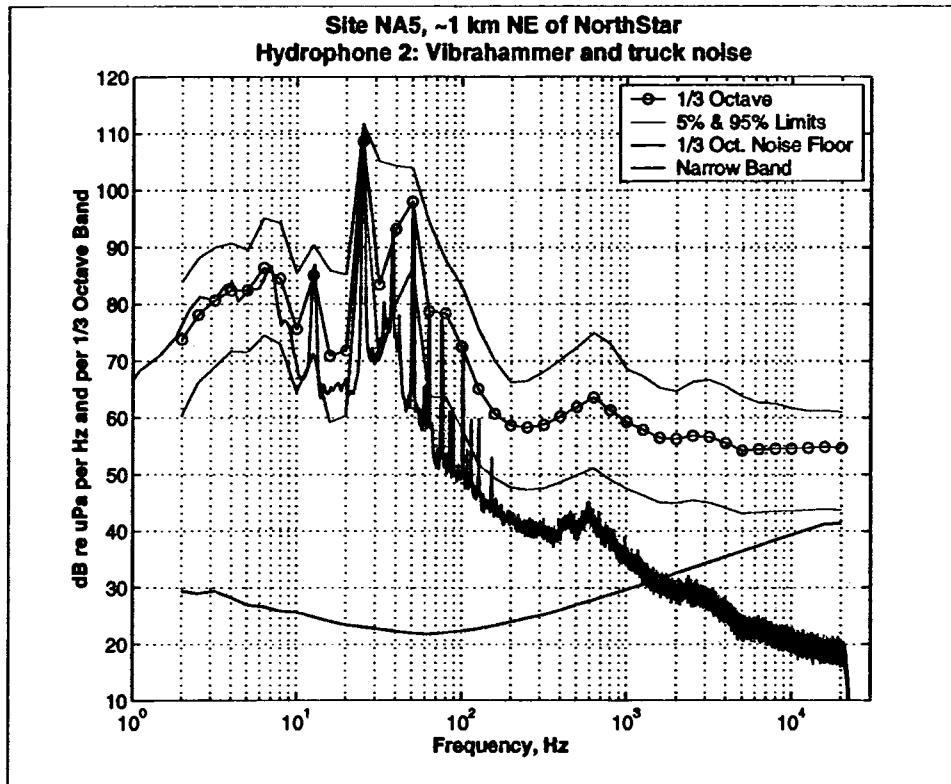
Figure 3.1.4- 8. Mid channel underwater noise levels at site NA5; strong vibrahammer. (10-0000)

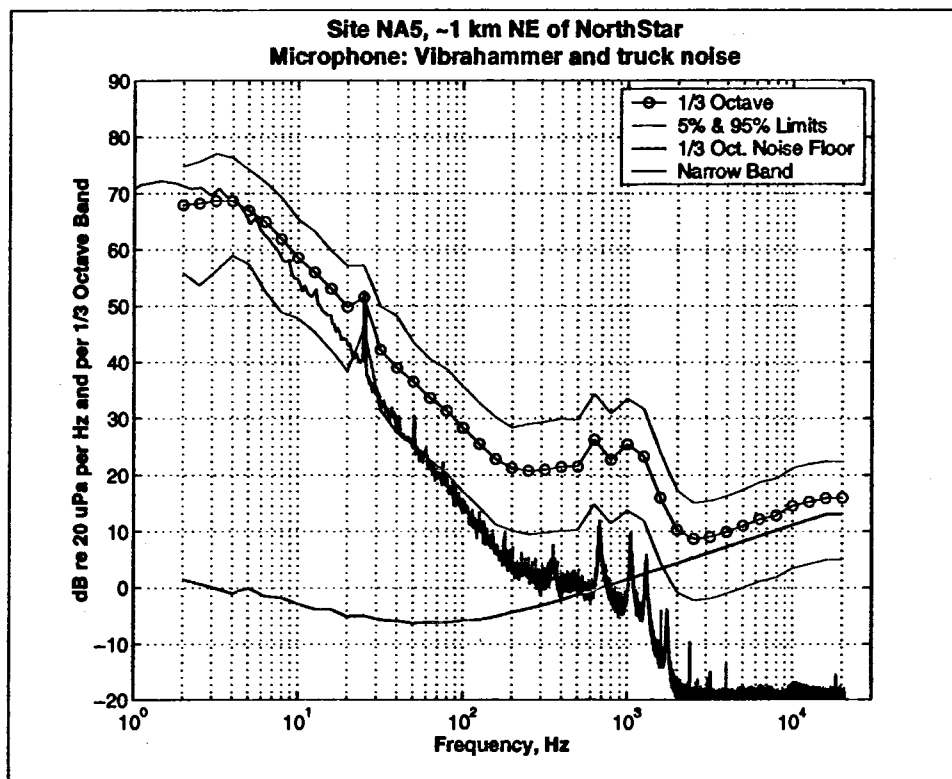
Figure 3.1.4- 9. In-air noise levels at site NA5; vibrahammer. (10-0000)

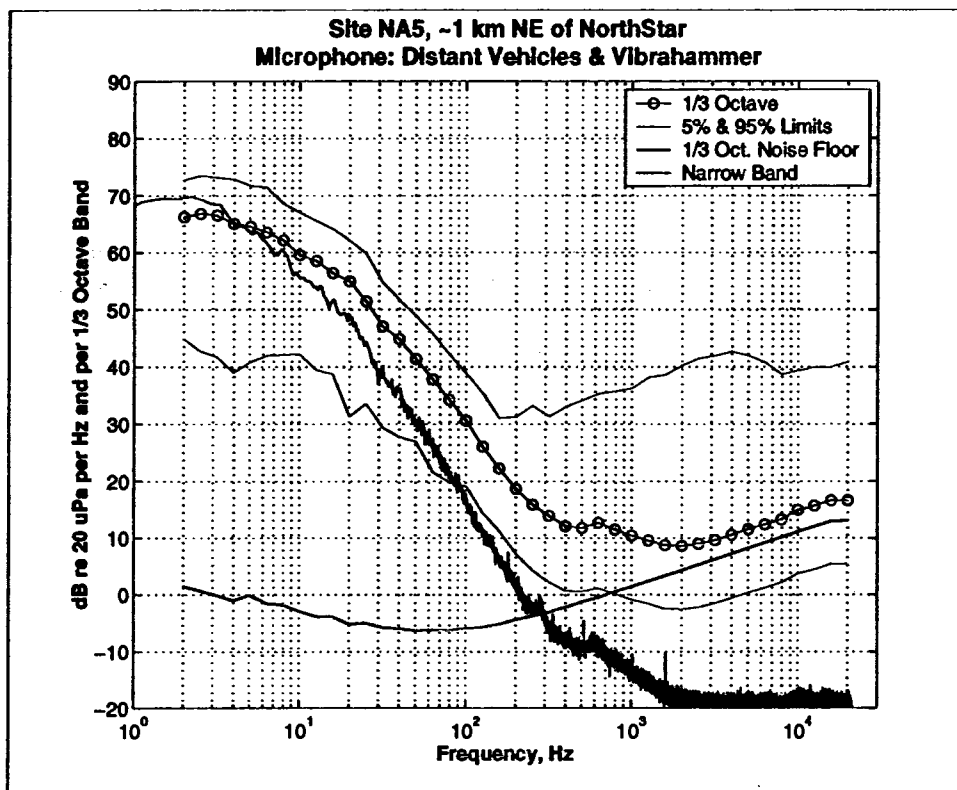
Figure 3.1.4- 11. Measured in-air noise levels at site NA5; no vibrahammer. (8-1200)

Figures 3.1.4-11 and 3.1.4-12 are two examples when the 23 Hz is not detectable in the air. Comparing the two, the former shows 2 to 8 dB higher noise levels in the 8 to 150 Hz band but 2-3 dB lower noise in the 300 to 1200 Hz region. The 1/3 OB levels are nearly comparable to the levels measured with the 23 Hz tonal present. This implies that the primary airborne noise sources are the machinery and vehicle noises at Northstar and individual samples are dependent on the amount of this activity at the time of data collection.

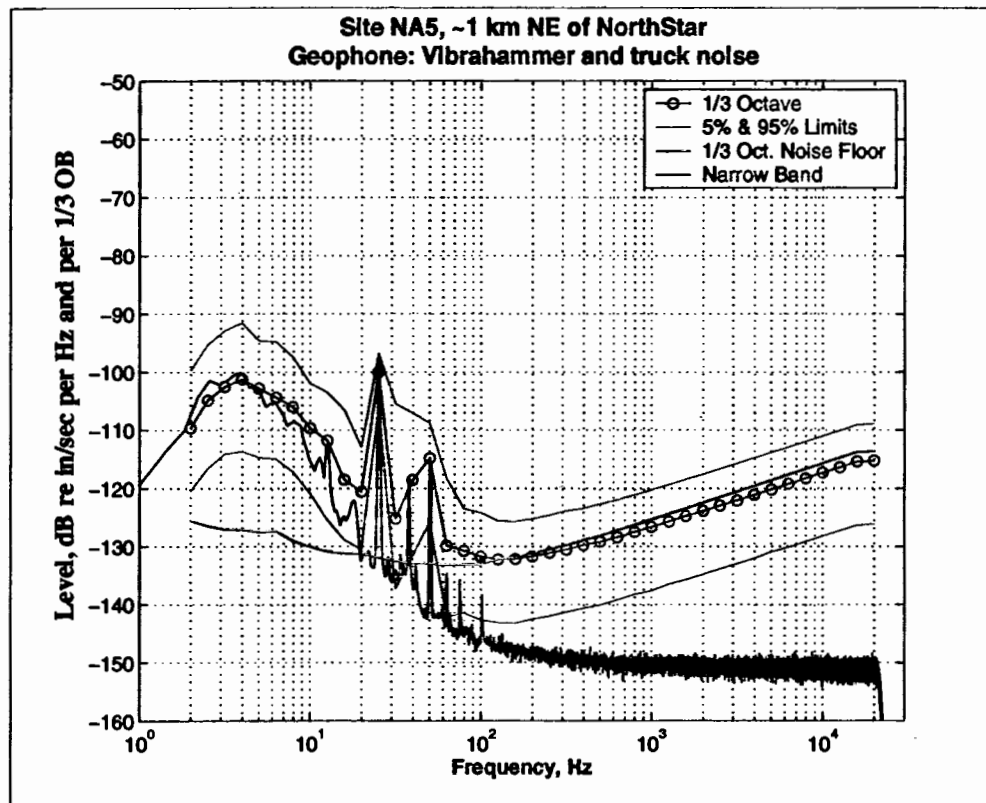
Figure 3.1.4- 13. Ice vibration noise levels at site NA5; vibrahammer. (10-0000)

Ice vibrations at site NA5 were only impacted by Northstar activities at frequencies below about 100 Hz. Two representative examples are provided in Figures 3.1.4-13 and 3.1.4-14. The most energetic measured vibration levels are shown in Figure 3.1.4-13. The dominant features are the narrowband tonals at 23, 39, 50, 61, 75 and 100 Hz plus

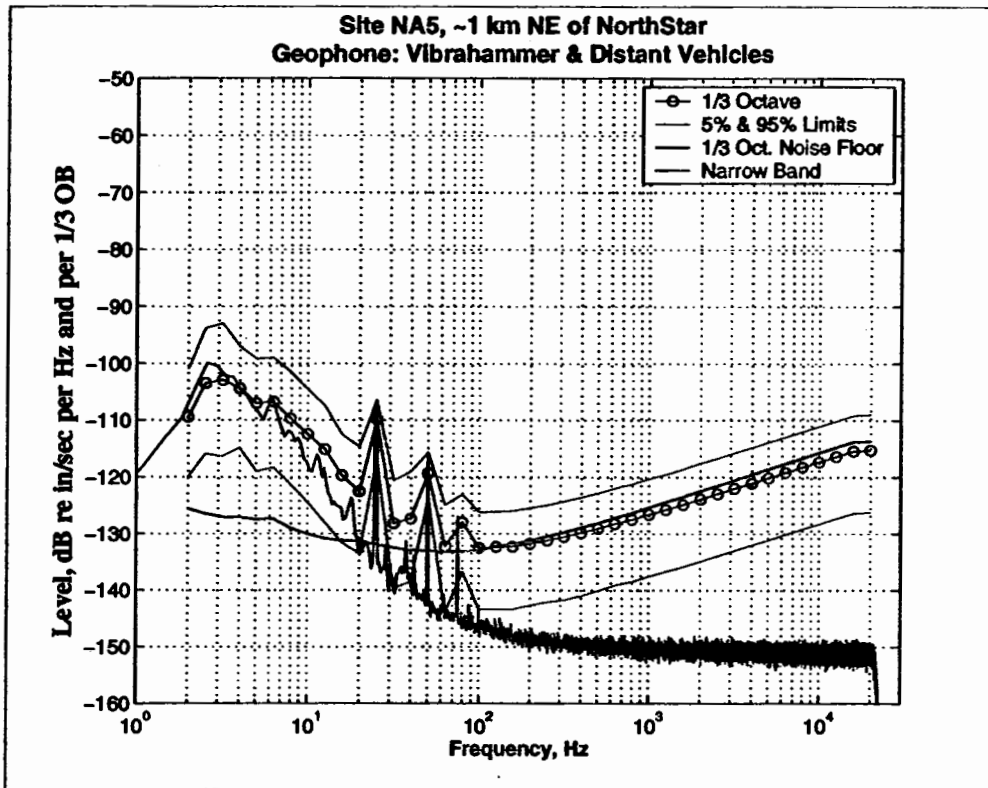
Figure 3.1.4- 14. Measured ice vibration levels at site NA5; vibrahammer. (10-1300)

In the second, quieter ice vibration example, the low frequency hump is still prominent but fewer significant tonals are present (23, 38, 50, and 73 Hz). Measured in-air noise shown in Figure 3.1.4-12 did not exhibit a strong 23 Hz tonal. However, both hydrophones (spectra not provided) had strong 23 Hz and other tonal components present. These observations lead to the conclusion that the vibrahammer noise propagates to the ice primarily through the ground and then briefly into the water. It is unclear whether the in-air vibrahammer noise is due to direct through-air propagation or is radiated from the ice into the air.

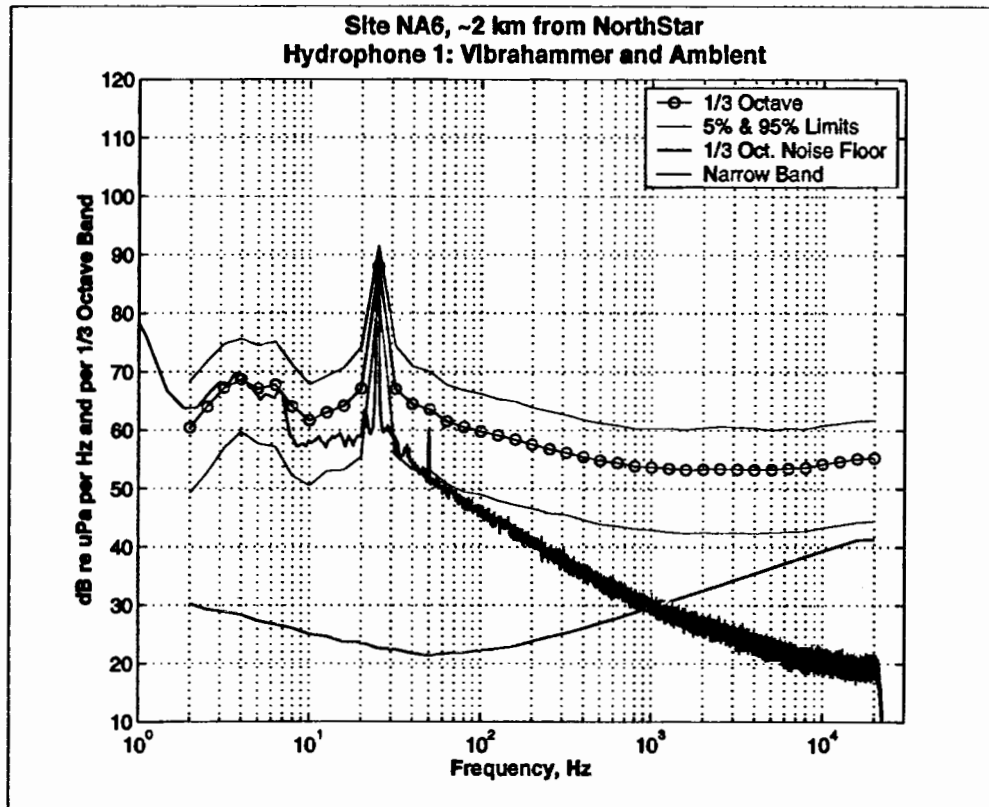
**Figure 3.1.5- 1. Near bottom underwater noise levels, site NA6; vibrahammer. (11-1300)**

Two examples of the conditions at NA6 are presented: one with strong vibrahammer noise and the other without. Figures 3.1.5-1 and 3.1.5-2 are spectra from the lower and mid-channel hydrophones respectively. Both exhibit the strong 23 Hz tonal, high low frequency noise levels below 10 Hz, and a tonal near 50 Hz. We hypothesize that the 50 Hz tonal is a machinery line and the low frequency energy is due to vehicle and machinery noise at Northstar.

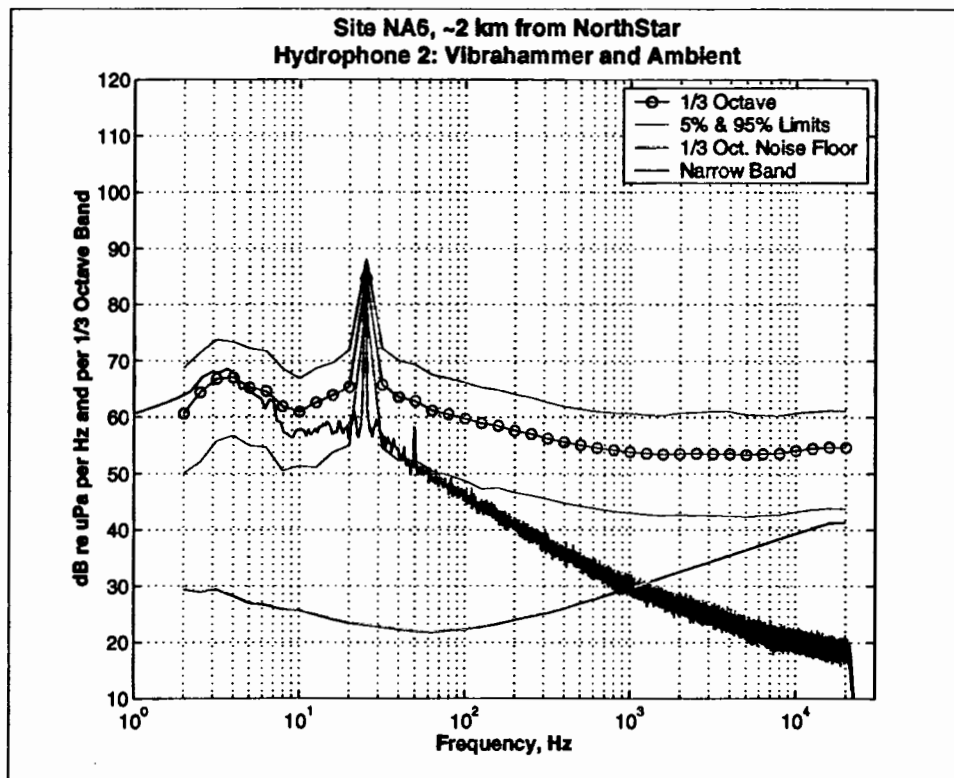
**Figure 3.1.5- 2. Mid channel underwater noise levels, site NA6; vibrahammer. (11-1300)**

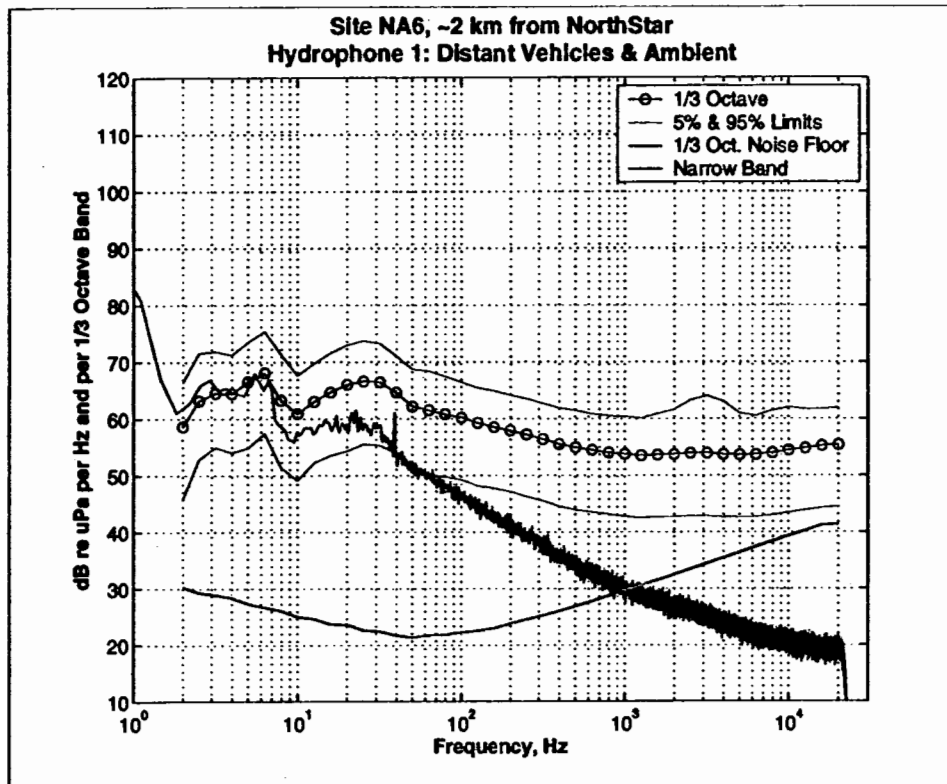
Figure 3.1.5- 3. Near bottom underwater noise levels at site NA6; no vibrahammer. (11-5330)

Figures 3.1.5-3 and 3.1.5-4 show spectra for the same two sensors when the 23 Hz vibrahammer sound is not present. The other features, namely the 50 Hz tonal and the high low frequency energy below 10 Hz are still present, albeit somewhat reduced in level. Over the rest of the band, the levels are nearly identical to those observed with the vibrahammer in operation. In both pairs of spectra, the deeper sensor exhibits slightly higher noise levels indicating noise radiation from the bottom.

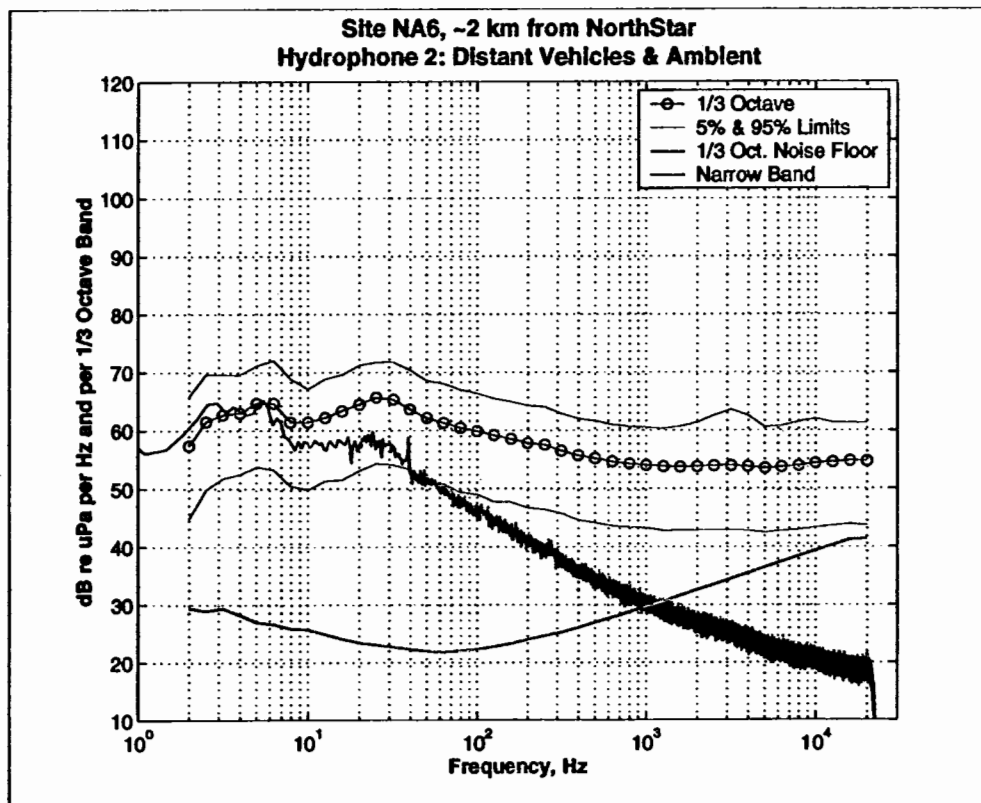
Figure 3.1.5- 4. Mid channel underwater noise levels at site NA6; no vibrahammer. (11-5330)

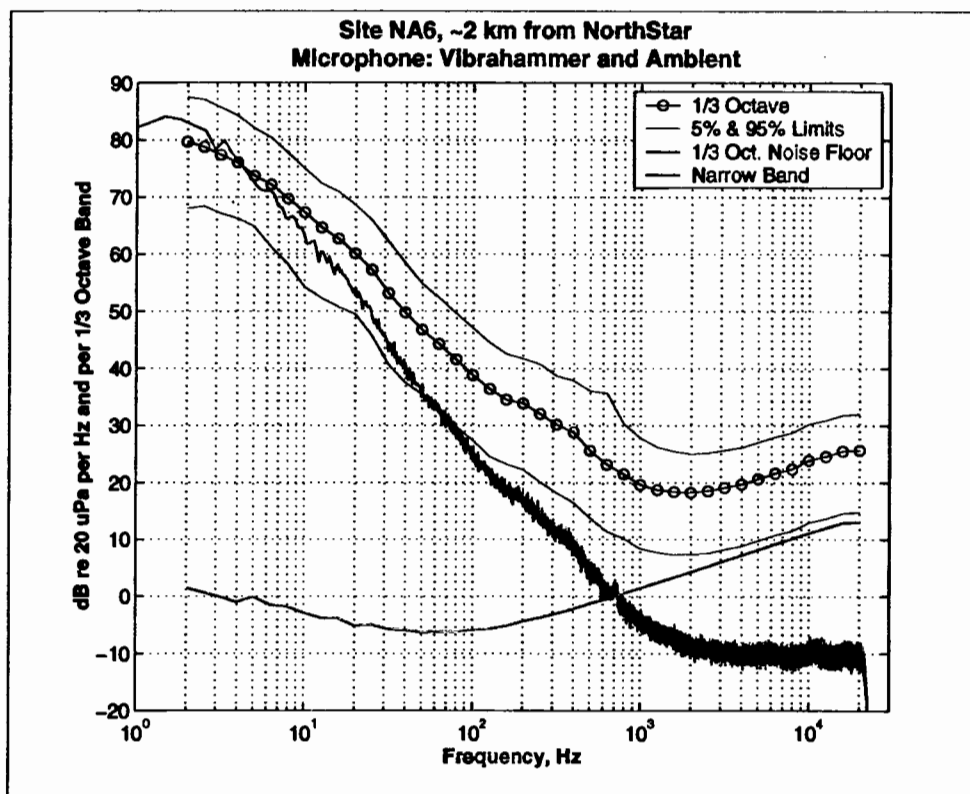
Figure 3.1.5- 5. Measured in-air noise levels at site NA6; vibrahammer. (11-1300)

Measured in-air noise levels for the same two time periods are shown in Figures 3.1.5-5 and 3.1.5-6. Both exhibit no significant narrowband spectral features. In the first case, the vibrahammer is in operation and the 1/3 OB noise levels are 2-10 dB higher than the second case without the vibrahammer excitation. In the band from 4 to 800 Hz, the narrowband noise spectral noise falls at a rate of about 10 dB per octave and the 1/3 OB noise decreases at 7 dB per octave.

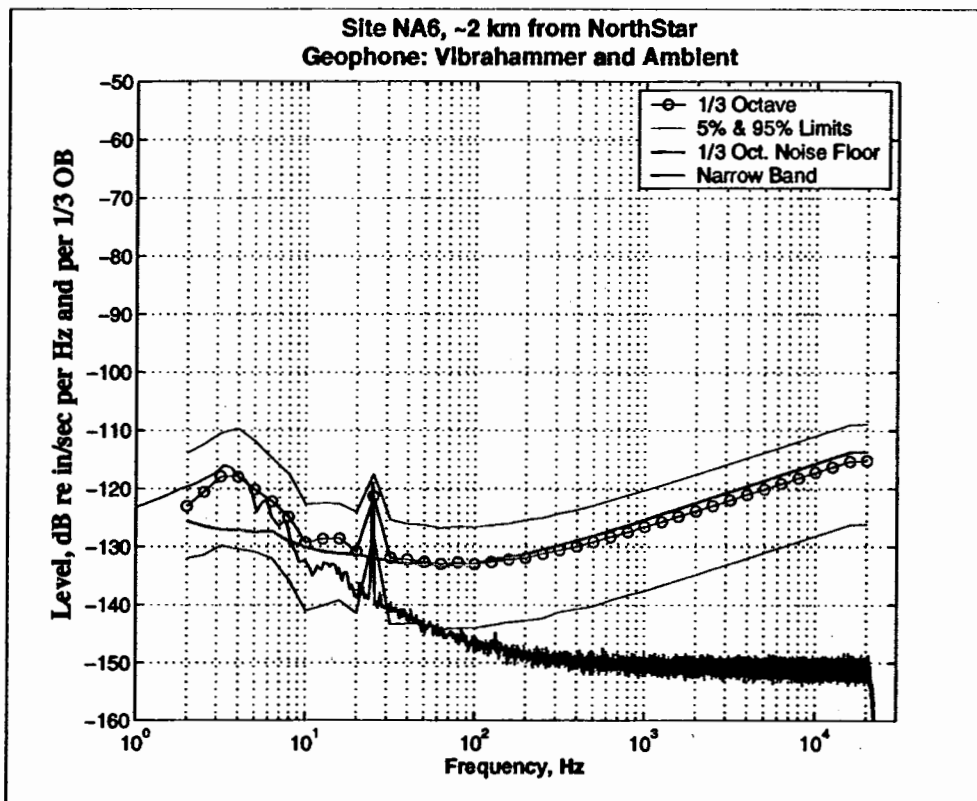
**Figure 3.1.5- 7. Measured ice vibration levels at site NA6; vibrahammer. (11-1300)**

As seen at site NA5, even when the microphone can't detect the vibrahammer's 23 Hz tonal, the geophone can detect the tonal. Figure 3.1.5-7 presents measured ice vibration levels with the vibrahammer in operation. The 23 Hz tonal is clearly evident. Only energy at 23 Hz and below 10 Hz is above the measurement system noise. The very low frequency noise is most likely due to vehicle and machinery noise at Northstar. In Figure 3.1.5-8, the 23 Hz tonal has disappeared leaving only measurable low frequency energy between about 2 and 6 Hz.

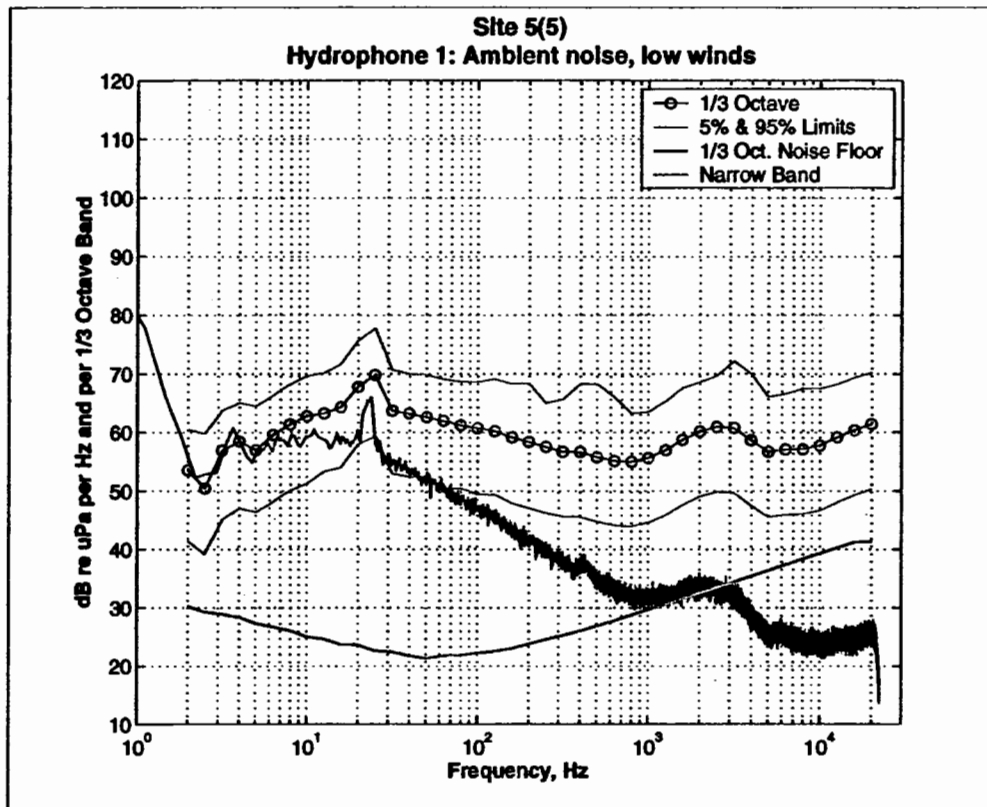
**Figure 3.1.6- 1. Near bottom underwater noise levels at site 5(5); lower winds. (5-0400)**

Figures 3.1.6-1 and 3.1.6-2 show measured noise spectra for the deeper hydrophone under both wind conditions. The average 1/3 OB levels are nearly identical. However, the 95<sup>th</sup> percentile level is considerably higher over the band from 40 Hz to 2 kHz. The same is true of the noise field at mid depth as shown in Figures 3.1.6-3 and 3.1.6-4. The noise is quite similar to those measured at site NA2 2.2 nm (4 km) from Northstar except for a much more significant energy peak centered at 22 Hz and a broad increase in the noise level from 1 to 5 kHz.

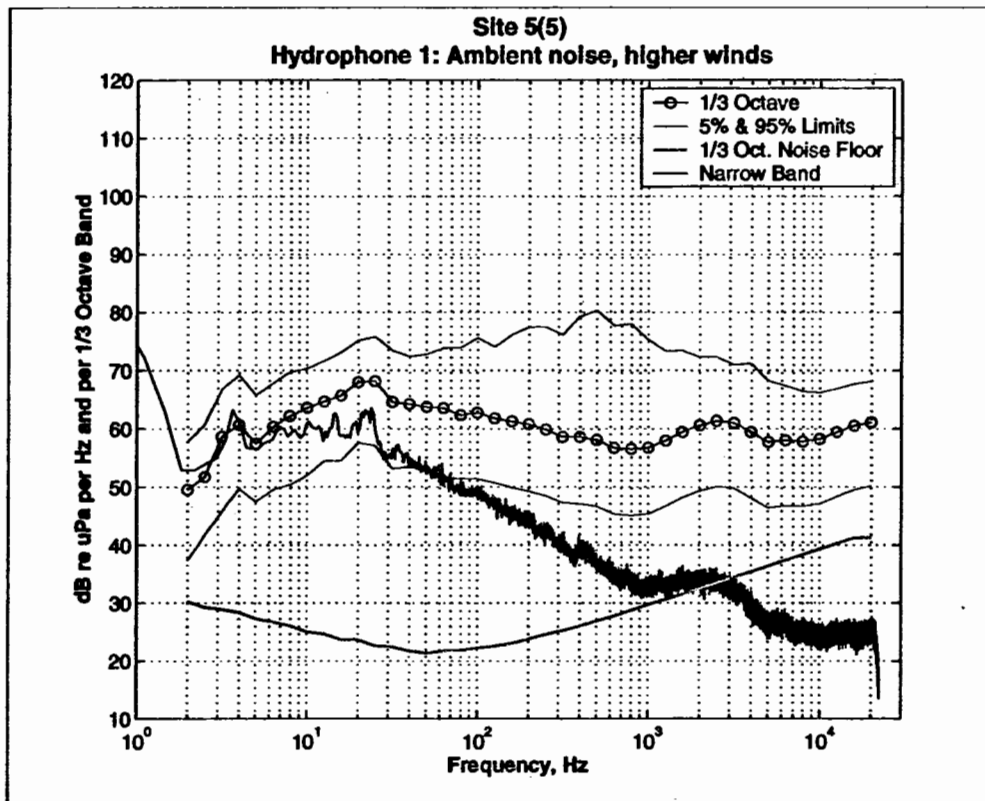
**Figure 3.1.6- 2. Near bottom underwater noise levels at site 5(5); higher winds. (5-6050)**

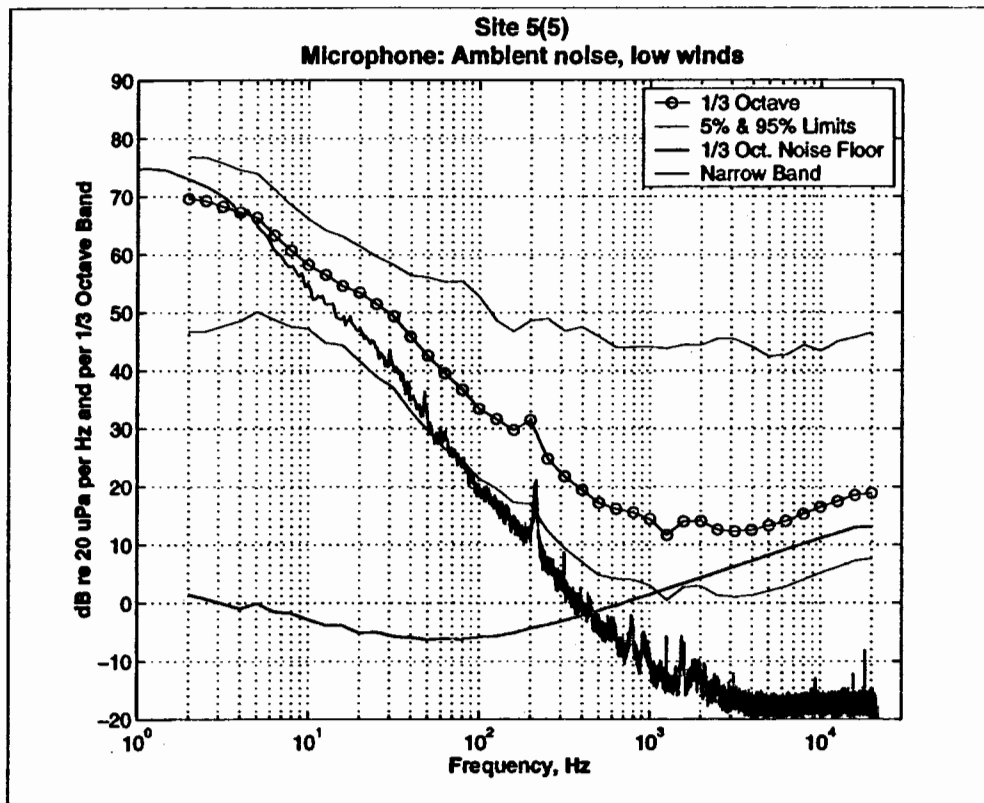
Figure 3.1.6- 5. Measured in-air noise levels at site 5(5). (5-0400)

Airborne noise at site 5(5) was higher than that observed at site NA2 under lower wind conditions. Figure 3.1.6-5 is a typical example. Below about 2 kHz, the noise level here is approximately 10 dB higher than at NA2. The other significant feature is a peak near 200 Hz, possibly caused by the distant caravan noted above. Data above 2 kHz is approaching the system noise floor limit.

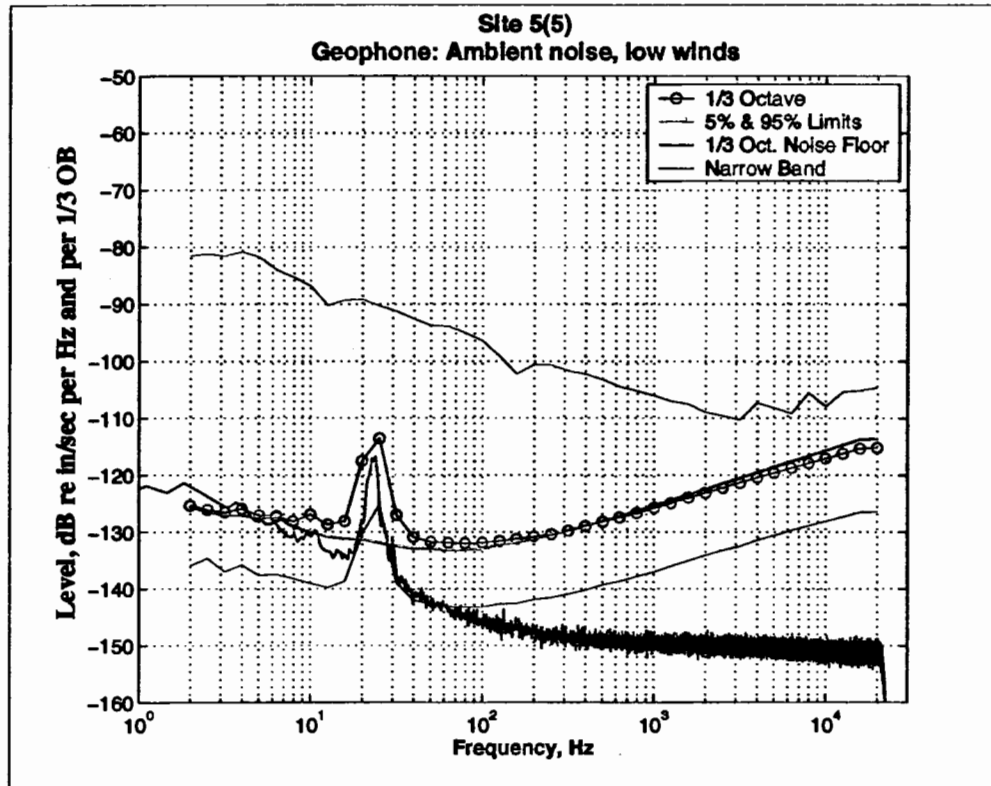
Figure 3.1.6- 6. Measured ice vibration levels at site 5(5). (5-0400)

The ice vibration levels at 5(5) were, as at site NA2, generally at or below our system noise floor (figure 3.1.6-6). As at NA2, only the small band from 12 to 30 Hz shows any sign of excitation above the noise floor. Here, the energy centered at about 22 Hz has a higher level by roughly 10 dB than at NA2 based on the narrowband spectra. It is not clear whether this excitation is from the same source as observed at NA2. The 5(5) peak is slightly higher in frequency. It is unlikely that the source of this vibration is vibrahammer operation at Northstar. Vibrahammer data collected at sites NA3, NA5, and NA6 all show a stable narrowband tonal at a slightly higher frequency and with a much smaller bandwidth.

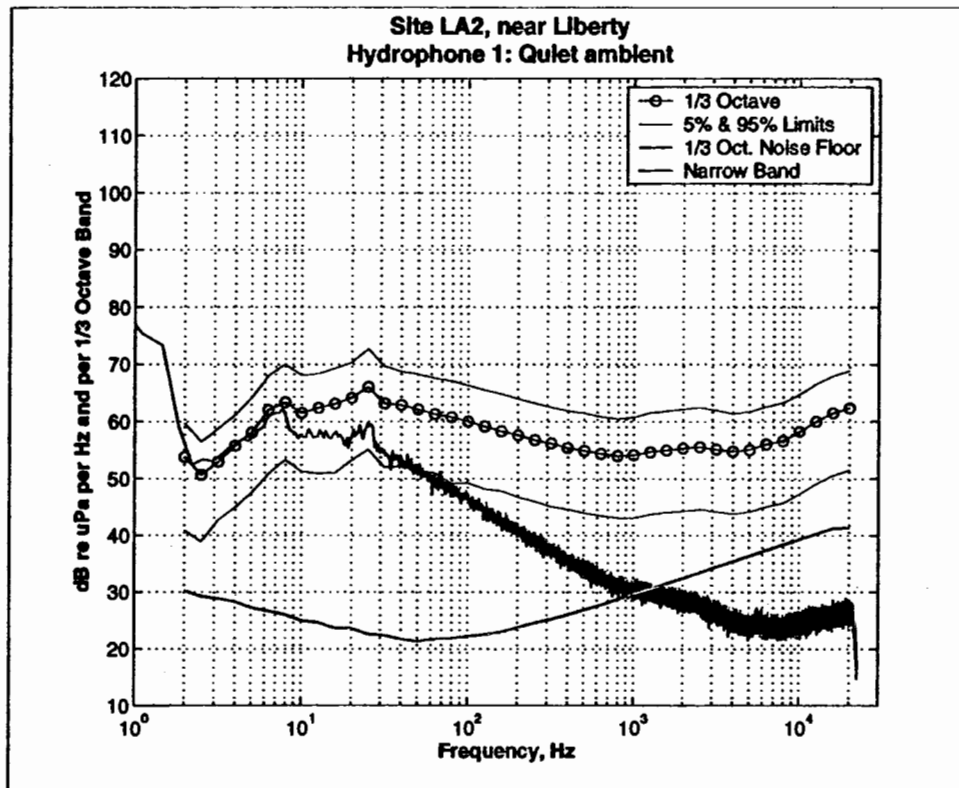
**Figure 3.2.1- 1. Near bottom underwater noise level measured at site LA2 (6-1200).**

Underwater noise spectra from the near bottom hydrophone at a 16 ft (5 m) depth and the mid depth sensor at 10 ft (3 m) are shown in Figures 3.2.1-1 and 3.2.1-2. Both plots have spectra nearly identical to those collected at site NA2. The only significant differences are a rise in noise level at high frequencies above about 7 kHz and higher levels of noise in the 20-30 Hz band. As before, the mid depth sensor measured a higher level of this 20-30 Hz energy than the near bottom hydrophone. As at NA2, this low frequency energy is also present in the ice vibration.

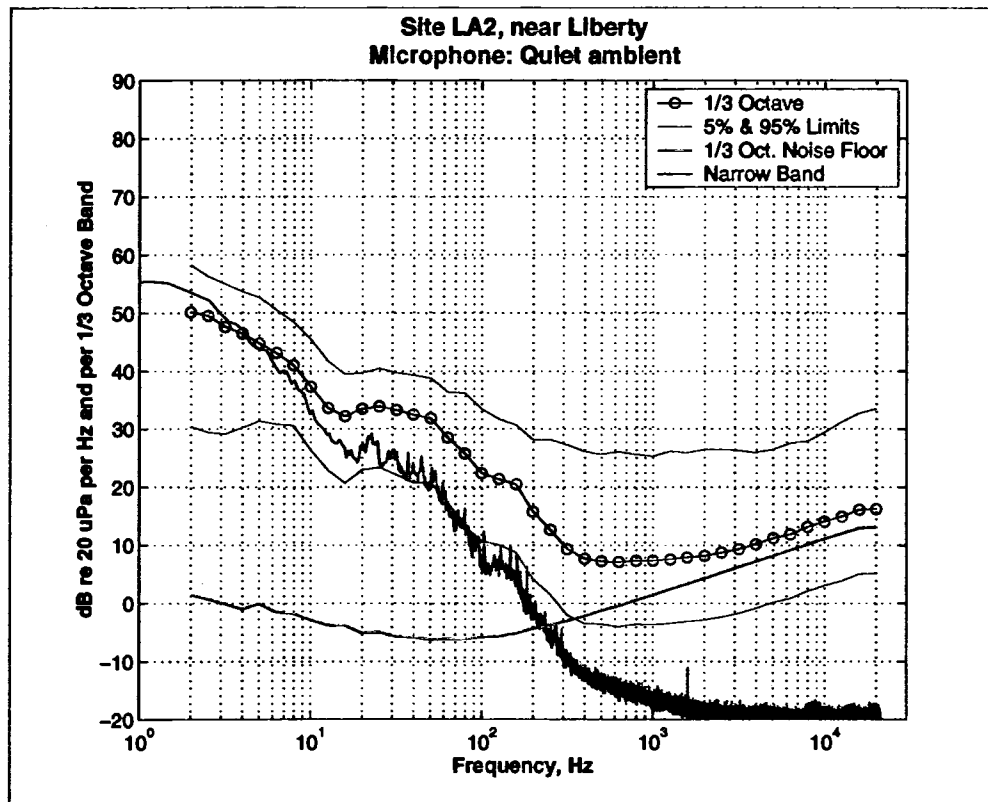
Figure 3.2.1- 3. Airborne noise level measured at site LA2 (6-1200).

In-air noise at LA2 is presented in Figure 3.2.1-3 while 3.2.1-4 displays the ice vibration spectrum collected using the geophone. The airborne noise level is also similar to those measured at NA2 except that the level approximately 5 dB quieter below 20 Hz. Energy in narrowband tonals is low with fewer lines present compared to NA2. As at NA2, the geophone detected very little energy except between 20 and 30 Hz.

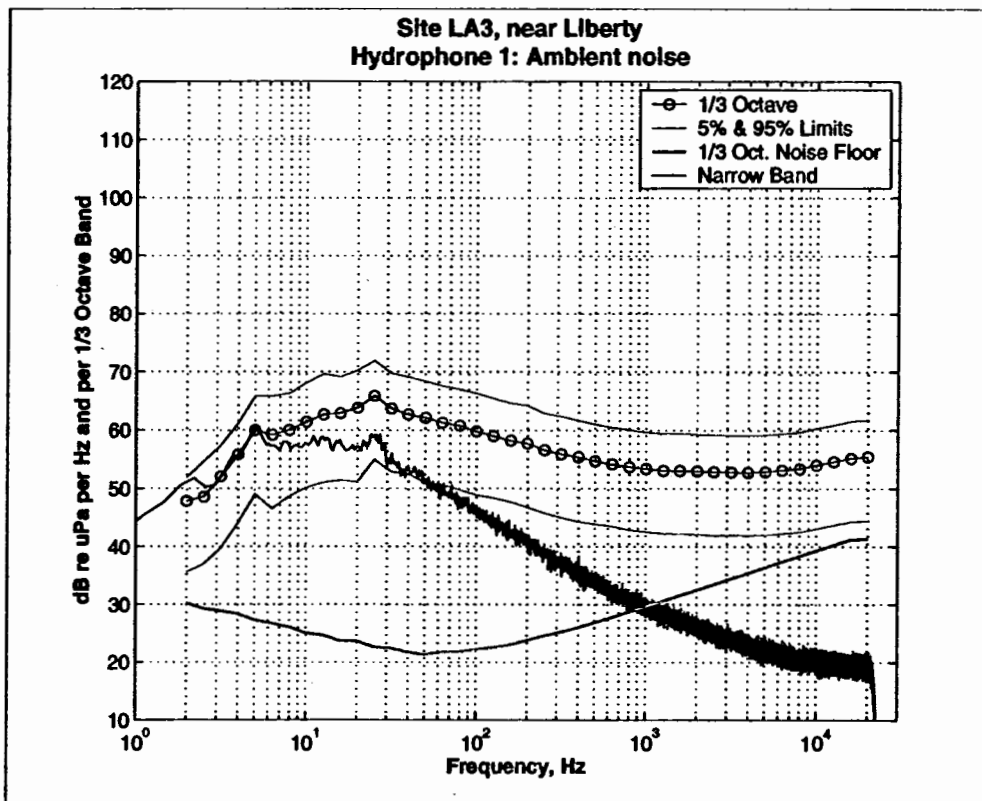
Figure 3.2.2- 1. Near bottom underwater noise level measured at site LA3 (7-5000).

With a water depth of 20 ft (6.1 m), the two hydrophones were deployed to the same depths used at LA2, namely, 10 and 16 ft (3 and 5 m). The spectra in Figures 3.2.2-1 and 3.2.2-2 display the data from the near bottom and mid depth sensors, respectively. The noise levels are comparable to the data collected to LA2 except that the increase above 7 kHz is not present. As encountered before, the energy peak in the 20-30 Hz band is much more energetic at mid water column than near the bottom. These data represent quiet conditions with potentially some contribution from the Endicott flare to the west.

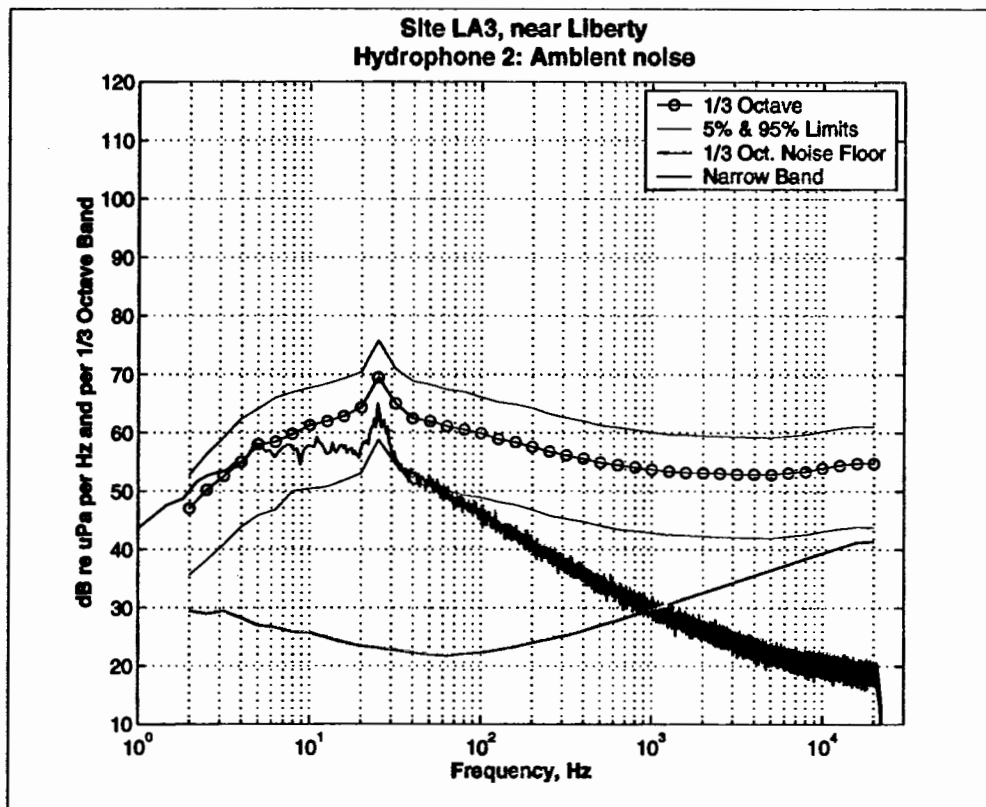
**Figure 3.2.2- 2. Mid channel underwater noise level measured at site LA3 (7-5000).**

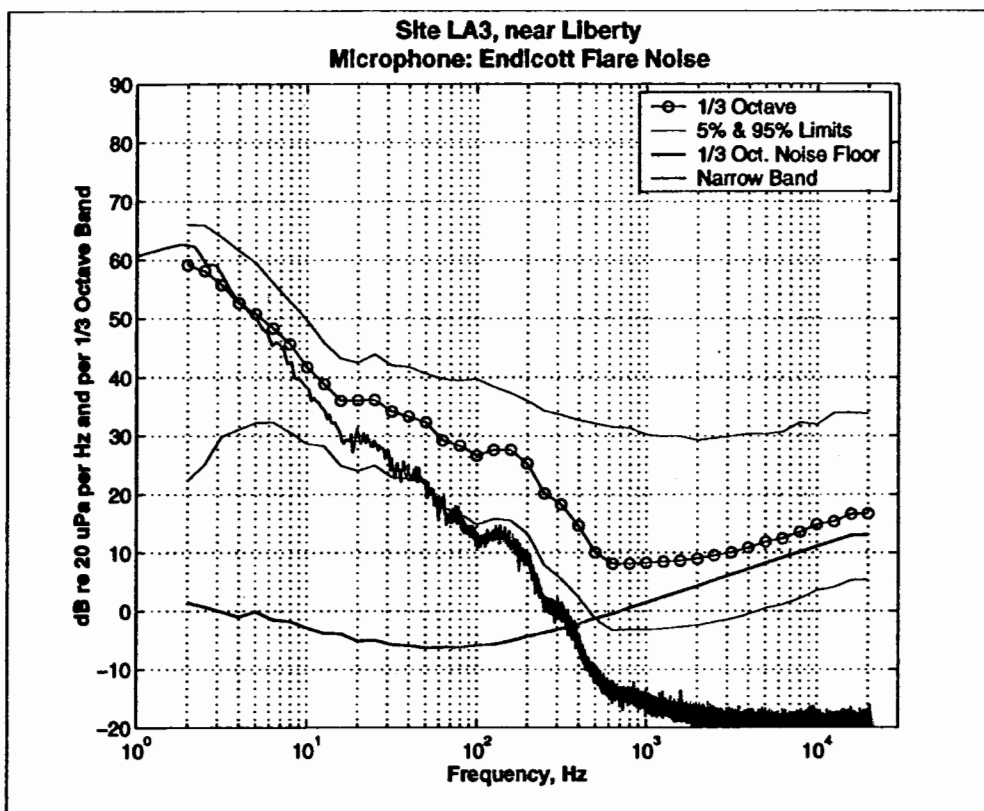
**Figure 3.2.2- 3. Airborne noise level with flare measured at site LA3 (7-5000).**

The only sensor with which we could detect the Endicott flare was the microphone. It sounded like a low rumble which faded in and out. The data from LA3 contained a time period when the flare was faintly but consistently evident and a time when the flare was undetectable aurally. Spectra from these two periods are presented in Figures 3.2.2-3 and 3.2.3-4. The noise levels are practically identical except in the 70 to 500 Hz band where as much as a 10 dB increase is seen in Figure 3.2.2-3. With no other evidence, we conclude that this rise in energy is due to the flare located approximately 10.3 nm (19 km) to the west-north-west.

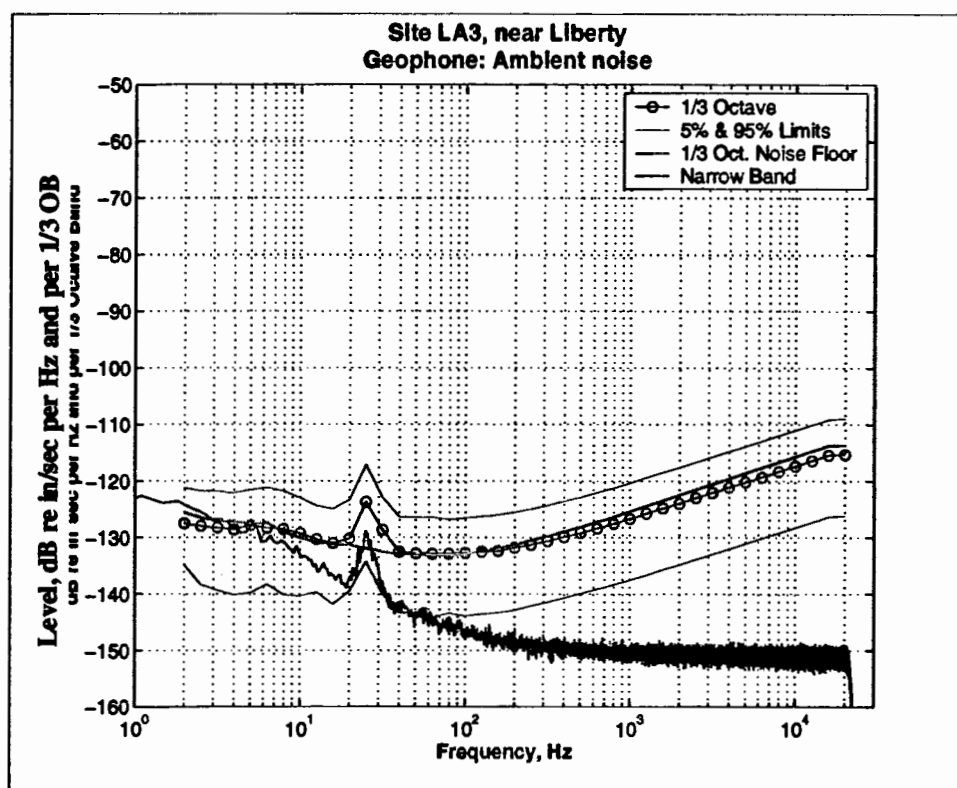
Figure 3.2.2- 5. Ice vibration noise spectrum measured at site LA3 (7-5000).

Measured ice vibration levels at LA3 are shown in Figure 3.2.3-5. As noted at LA2 and NA2, the only observable energy above the noise floor is in the 20-30 Hz band, the same spectral region that peaks in the mid depth hydrophone data. The source of this energy is unknown at this time.

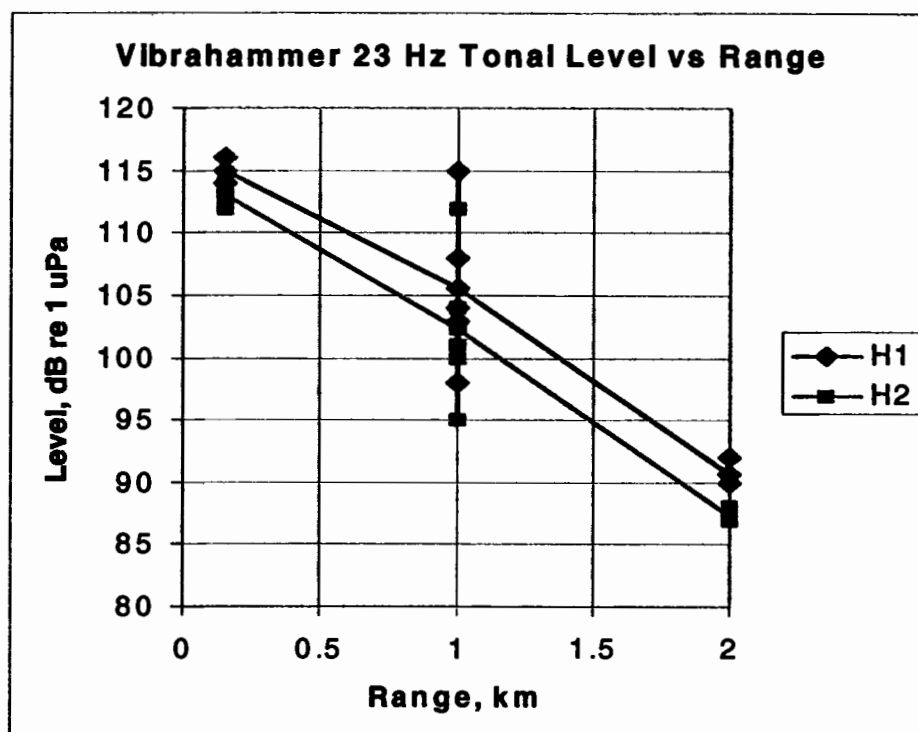
Figure 4.1- 1. Vibrahammer 23 Hz tonal spectrum level as a function of range as received on the near-bottom hydrophone (H1) and mid-channel depth hydrophone (H2).

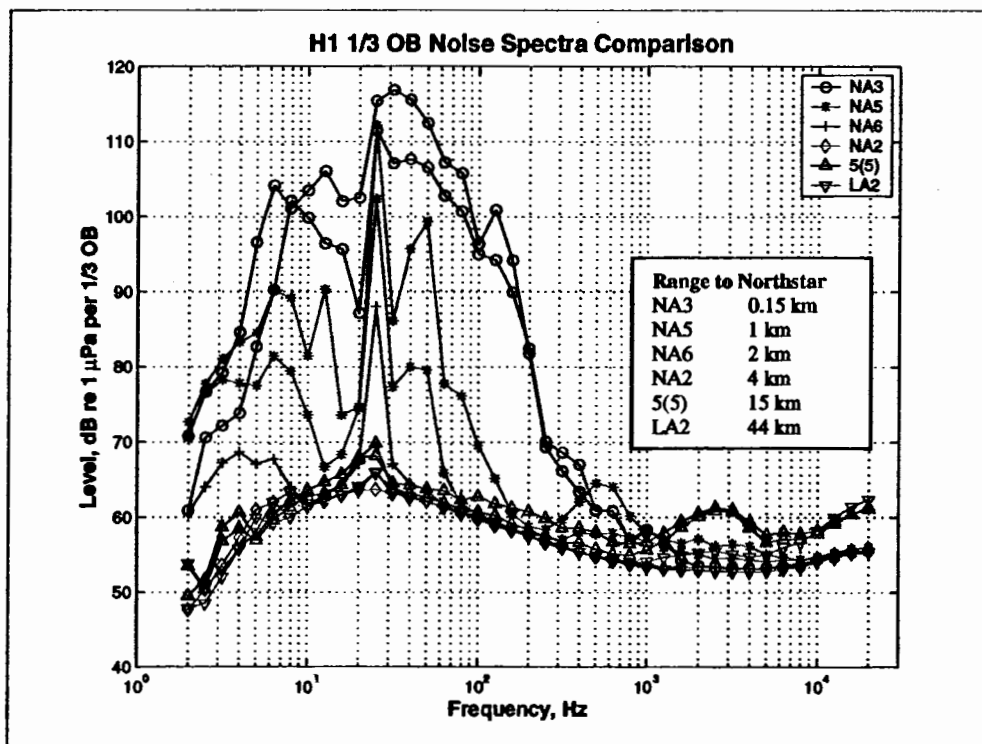
Figure 4.1-2 presents the measured 1/3 OB noise spectra collected at four sites near Northstar plus site 5(5) and site LA2. All spectra from sites NA3, NA5, and NA6 were calculated while the vibrohammer was in operation. It is not known if the vibrohammer was operational during the other analyzed segments.

Close to Northstar at NA3 (range = 0.08 nm or 0.15 km), underwater noise is dominated by radiation from the island below 500 Hz, rising as much as 45 dB above quiet background noise as represented by the spectra taken at site NA2. Half a nautical mile (1

Figure 4.1- 2. Comparison of 1/3 OB spectra at multiple sites collected during vibrohammer operation using the hydrophone positioned near the bottom (H1).

km) from Northstar (site NA5), man-made noise dominates only in the spectral region below about 100 Hz. And at a range of 1.1 nm (2 km) (NA6), only energy in the 23 Hz tonal and at very low frequencies below about 7 Hz is detectable above ambient levels.
